## SECTION I - FOREWORD

## SECTION II - SUMMARY AND DISCUSSION

TORPEDO DAMAGE

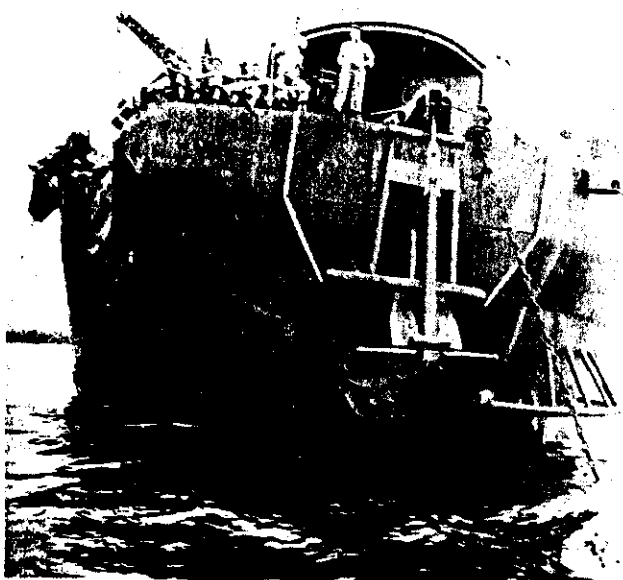
2. The ship's structure and equipment aft of frame 41 were largely wrecked (photos 1 through 4). The port rudder, propeller and the tail section of the port shaft were carried away. Although the starboard rudder and propeller remained intact, the rudder was jammed at hard right and the propeller shaft suffered a considerable misalignment. The port stern tube and stern tube casting later were found to be missing. The starboard stern tube and stern tube casting were damaged beyond repair. The shell was ruptured over an area extending from frame 46 to the after perpendicular and from the B strake on the starboard side to the second deck on the port side. The third and second decks were ruptured throughout a comparable area. The main deck was deflected upward in way of the damaged area below, and split at some seams on the port side. The steering gear compartment was completely wrecked and the steering gear demolished. The crew's quarters likewise were wrecked.

Photo 1: LST471 - Stern view showing torpedo damage to shell.

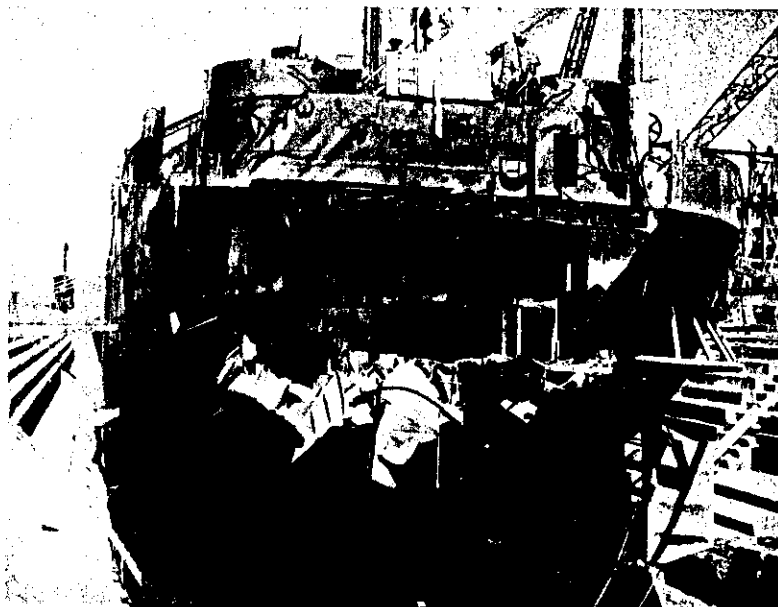
Photo 4: LST471 - View of stern after decks had been cut away.
