# DESTROYER REPORT

## GUNFIRE, BOMB AND KAMIKAZE DAMAGE

### INCLUDING LOSSES IN ACTION

### WAR DAMAGE REPORT No. 51

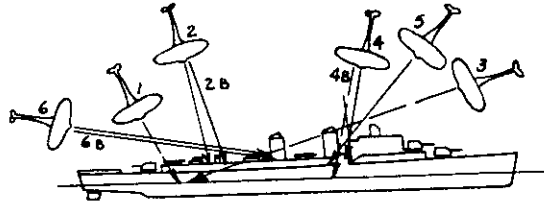
SHIP  
AARON WARD  
(DM34)

- 1 Near miss crash. Engine and propeller hit Mt. 3.
- 2 ZEKE hit Mt. 44.
- 2B Bomb blew out side after engine room.
- 3 Near miss crash damaged rigging and No. 1 stack.
- 4 VAL hit main deck, frame 81.
- 4B Near miss bomb blew side forward fireroom.
- 5 VAL crashed deckhouse frame 90.
- 6 Plane hit after stack.
- 6B Bomb detonated in aft uptakes.
