Subject: Report of Action on 29 November 1944,
Forwarding of.

U.S.S. AULICK (DD569)

From: The Commanding Officer.
To : The Commander-In-Chief, U.S. Fleet.
Subject: Damage Report.

USS AULICK (DD569)
 Anti aircraft action
 29 November 1944.

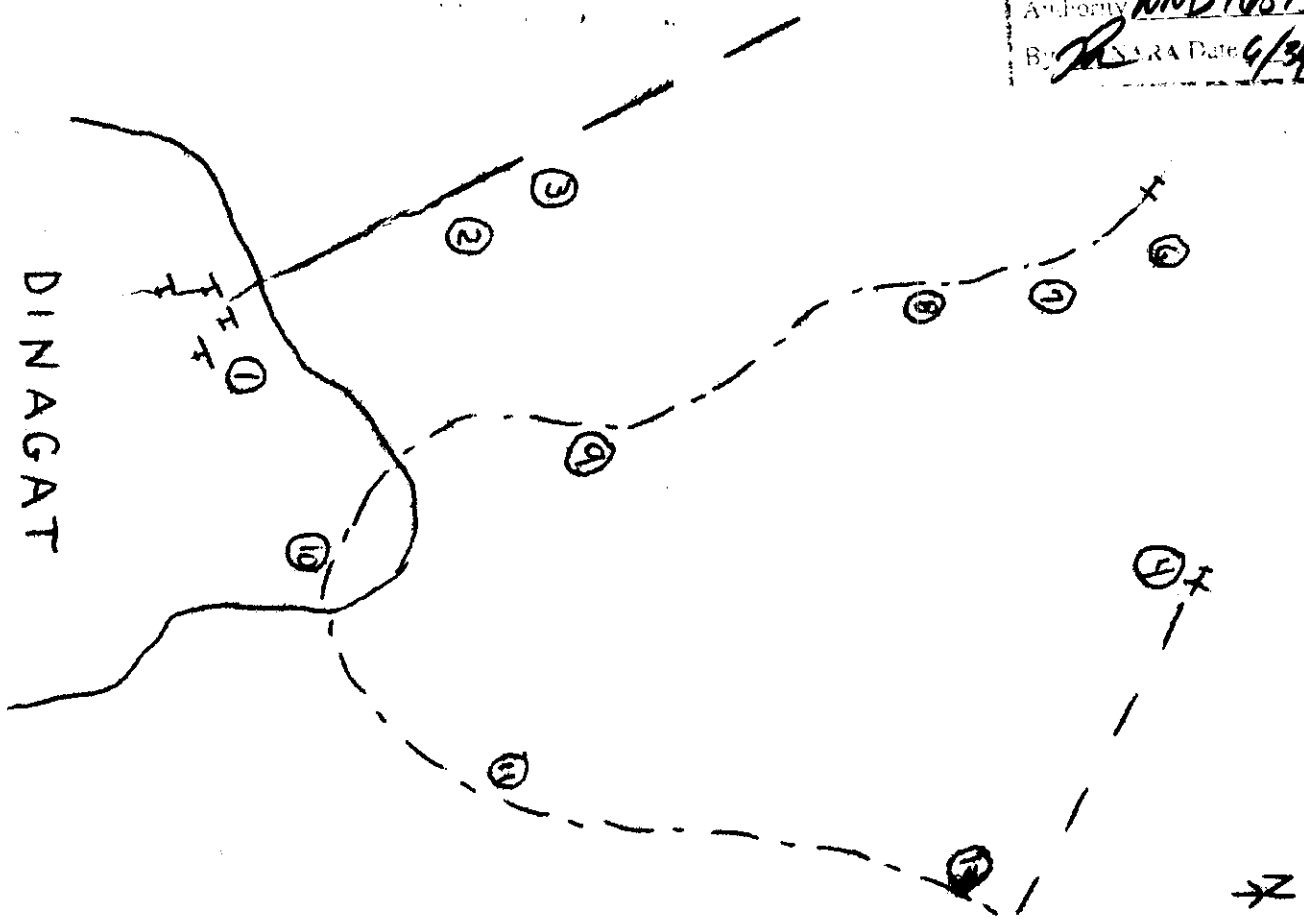
- 1 - Formation of 4 Oscars sighted.
- 2 - 5"/38 battery commenced fire as ship swung left
- 3 - Checked fire to shift to plane making run from astern
- 4 - Commenced fire on first attacking Oscar
- 5 - Ship turning to starboard as plane crashed off port bow.
- 6 - Second Oscar sighted
- 7 - Control on target
- 8 - 5"/38 battery commenced firing
- 9 - 40mm battery commenced firing
- 10 - Irreparable 40mm hits
- 11 - 20mm battery commenced firing
- 12 - Known 20mm hits
- 13 - Plane started burning.
- 14 - Second Oscar exploded off starboard bow as ship was backing full with hard right rudder
