U.S.S. HARDING (DMS-28)  
c/o Fleet Post Office,  
San Francisco, California

From: The Commanding Officer.  
To: The Bureau of Ships.  
Subject: War Damage Report.  
References: (a) PacFlt Conf. Ltr. 33CL43 (Rev.)  
(b) BuShip's Ltr. C-FS/L11-1(374) over  
C-EN28/A2-11 of 17 April 1942.  
Enclosure: (A) War Damage Report, U.S.S. HARDING(DMS-28) of  
16 April 1945.  
(B) Harding serial 004 of 24 April 1945 - Report of  
Damage Incurred 16 April 1945.

Subject: Report of Damage Incurred 16 April 1945.

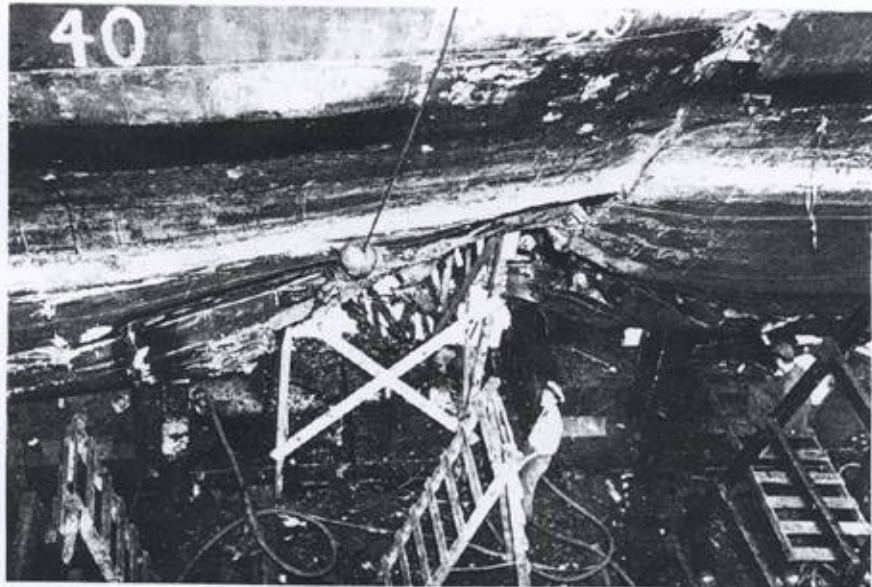
Looking down at frames 40 and 35, starboard side.

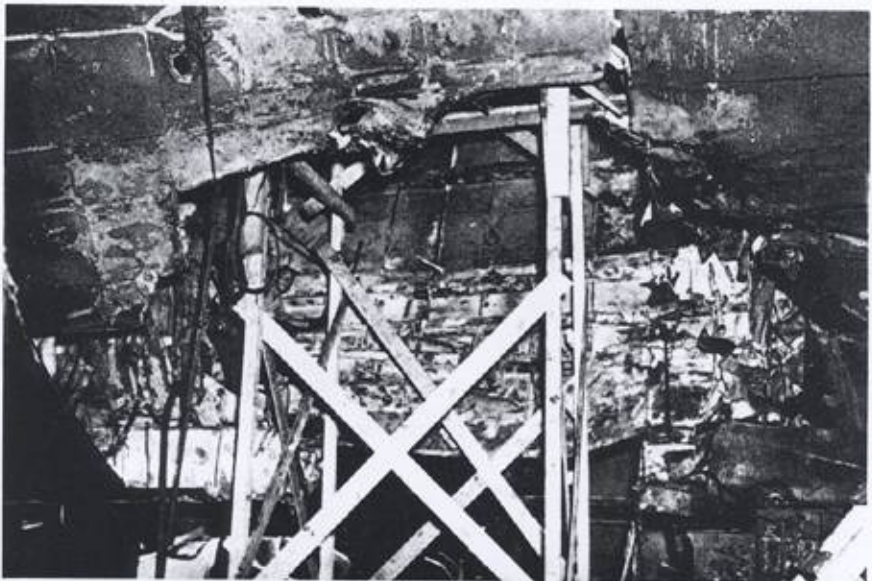
Looking up at frames 40 and 35, starboard side.

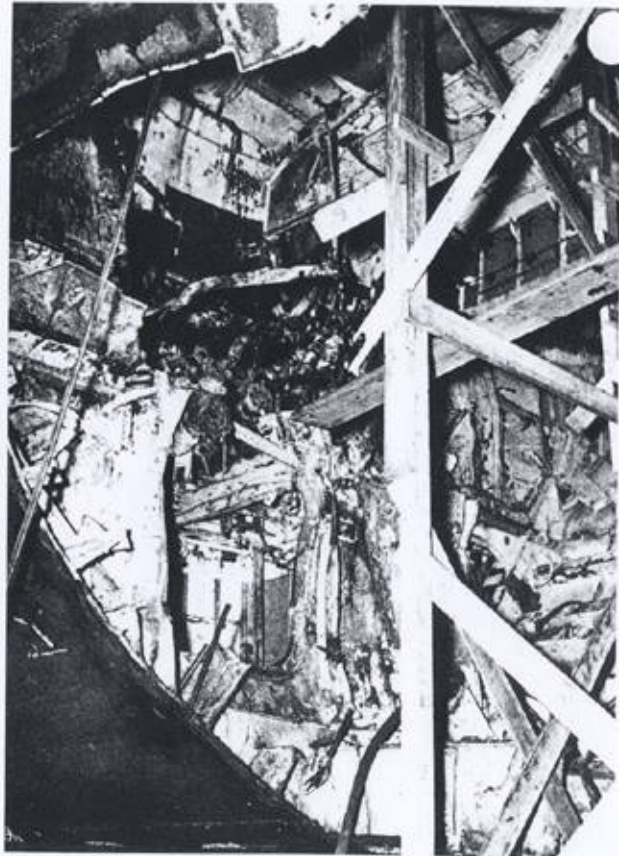
Looking up into frame 40, starboard side.

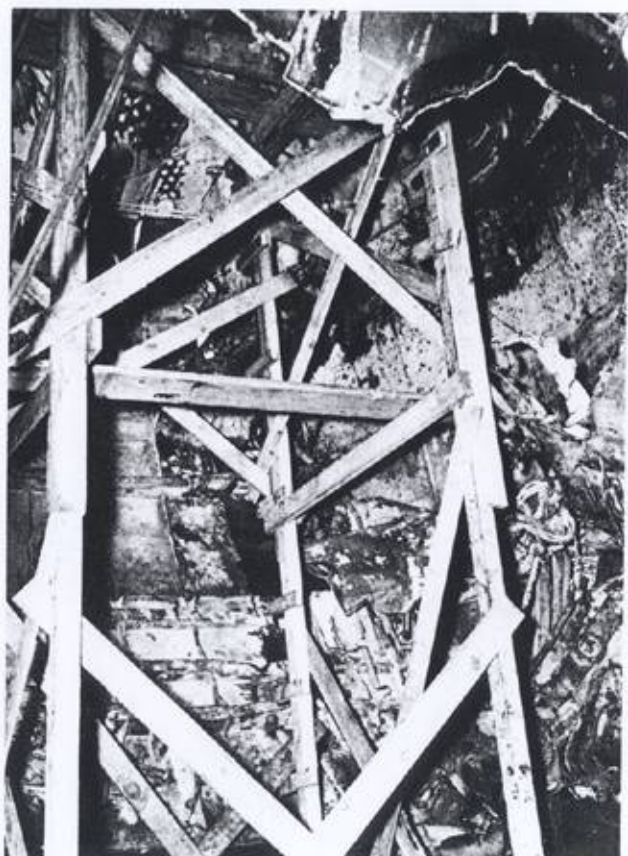
Looking up into frame 35, starboard side.

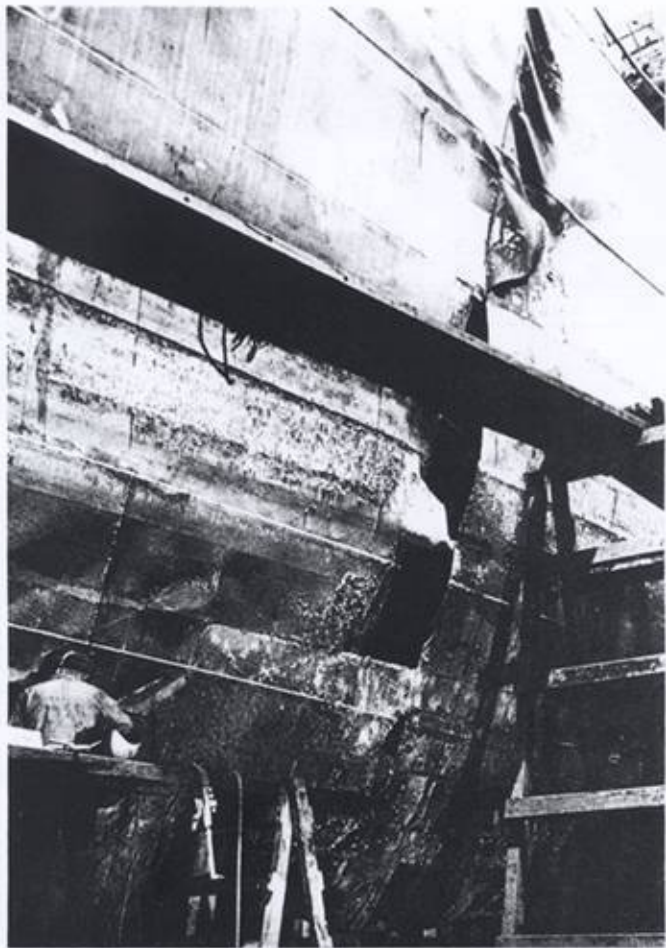
Frame 30, port side looking aft.

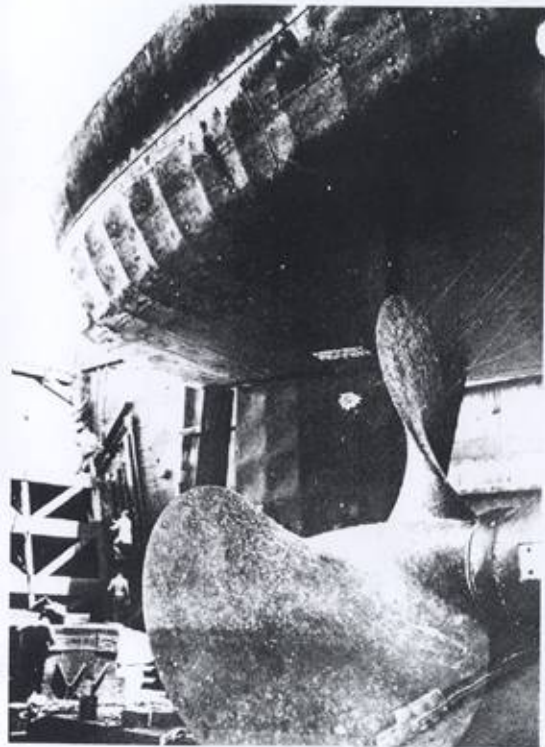
Screw and fantail from starboard side aft.

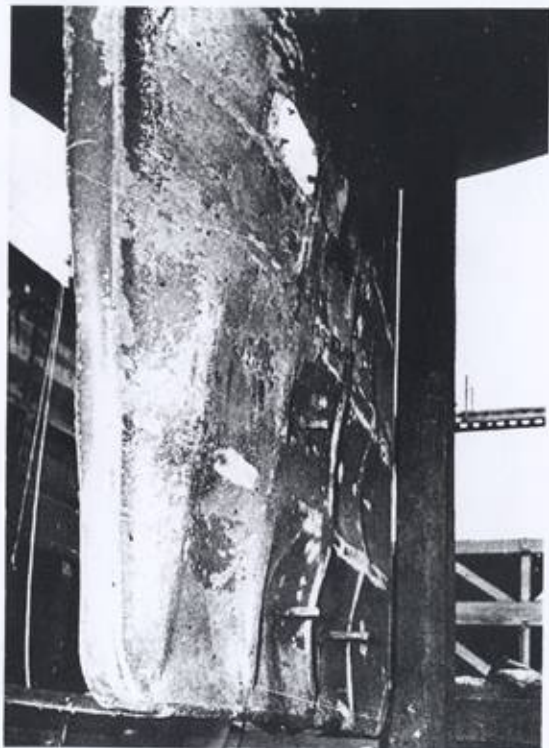
Rudder from port side aft.
